ARKANSAS STATE HOSPITAL (ASH) – Vocational /Maintenance Shop Building

Building Location: 4313 W Markham Street Little Rock, Arkansas

Date of Site Visit: 9/07/06

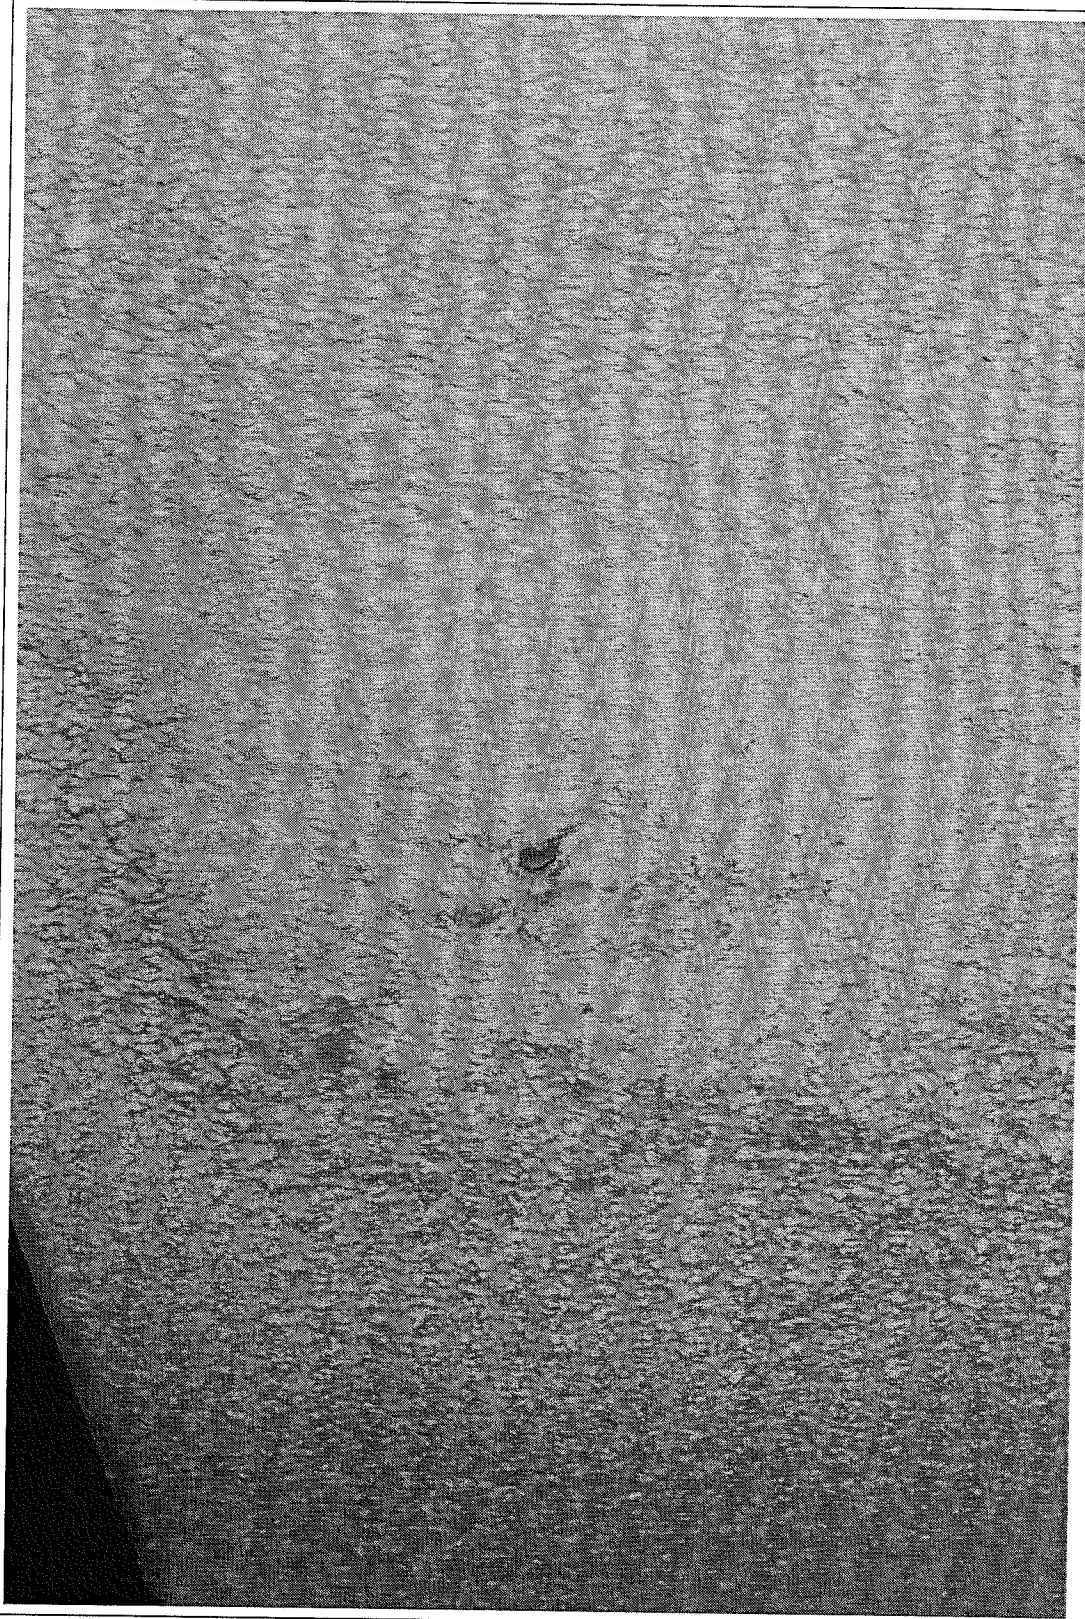
Photo 54. Unit 2 Hallway outside Office Area - Water damaged acoustical plaster ceiling

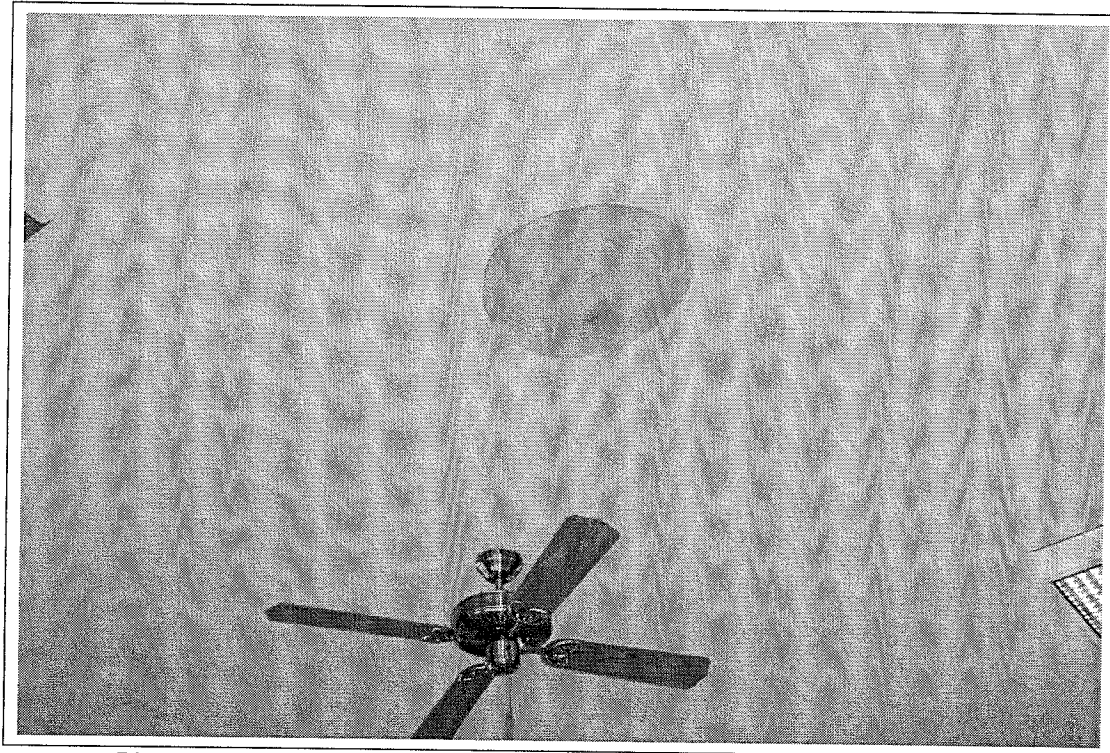
Photo 55. Unit 2 Visiting Area - General view of acoustical plaster ceiling

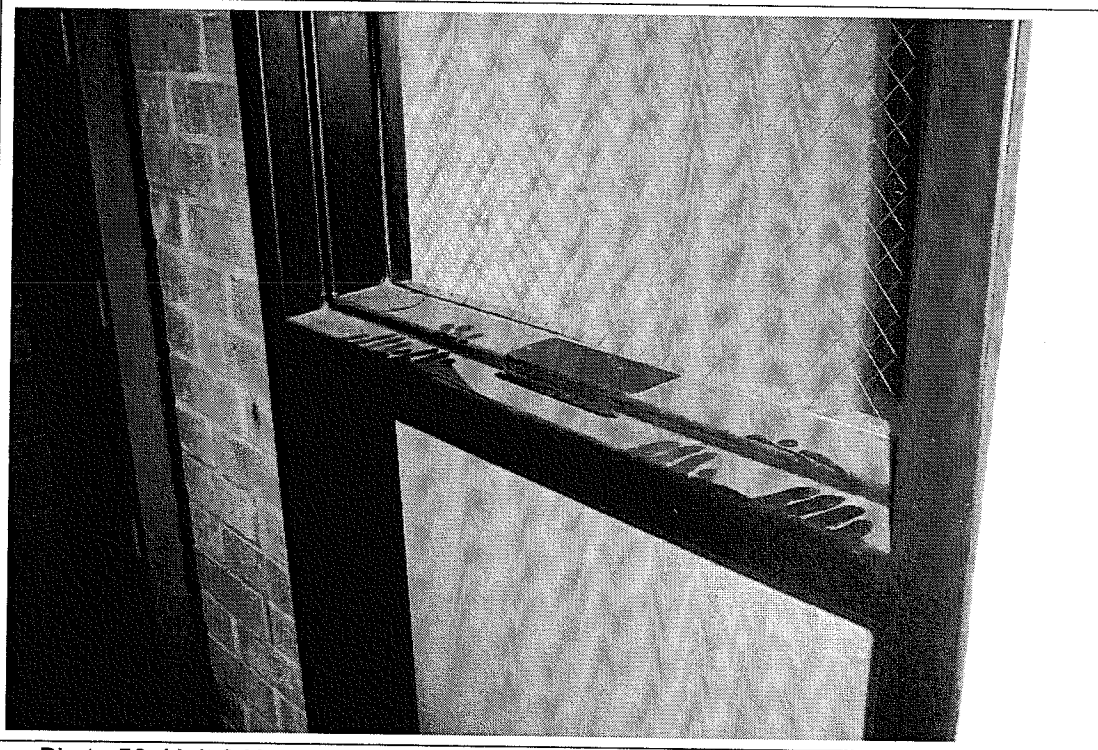
Photo 56. Unit 3 Upper Quad C - Location of dust sample #1 (top of interior window ledge above restroom)
